TECHNICAL MEMORANDUM

SUBJECT: Site visit report

SITE: DTG-Anderson Landfill

DATE: January 20, 2023

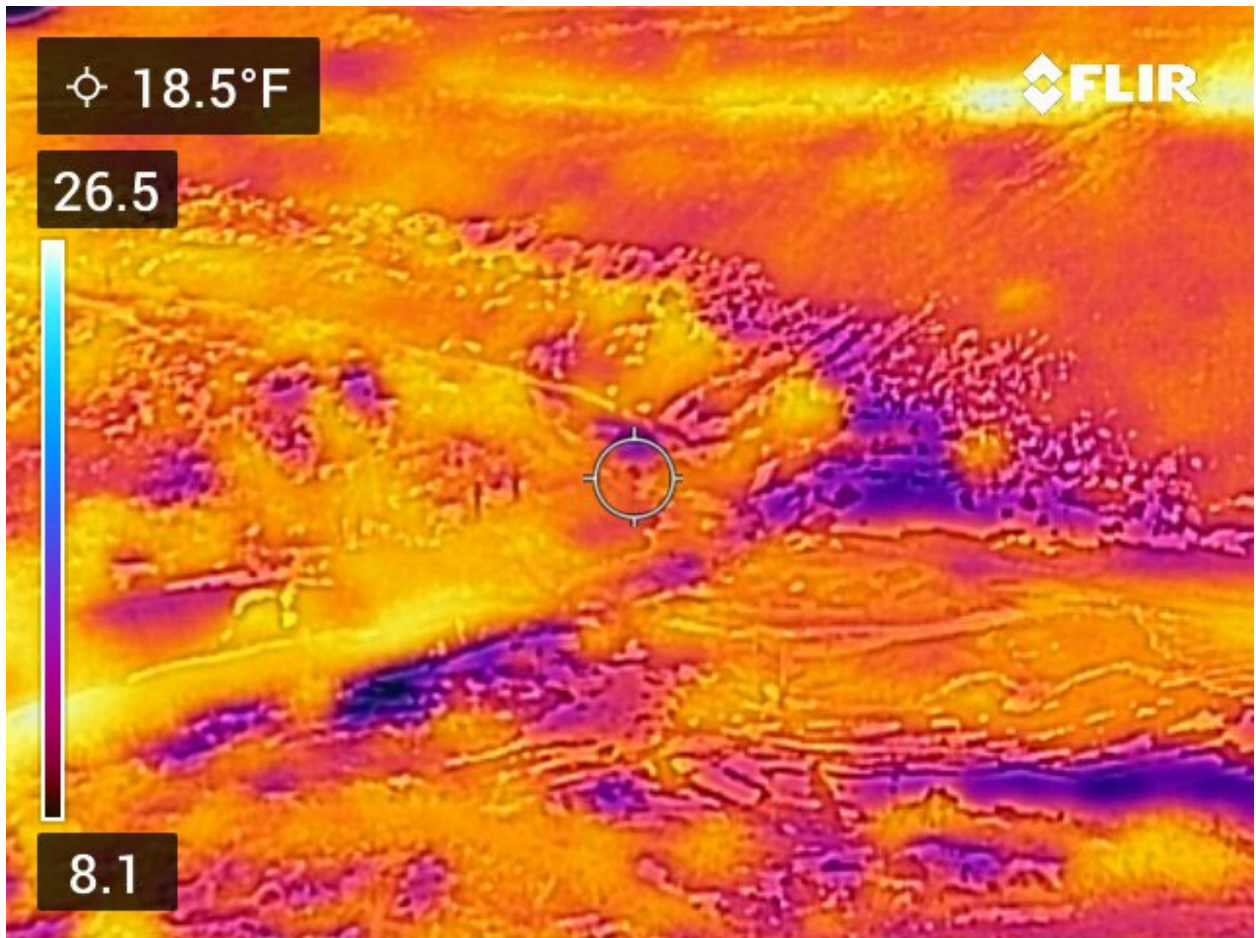
From the top of the draw, I proceeded on foot along the quarry haul-road to the west of the existing landfill until I was east of MW-4. From that vantage point I took a series of photos with my phone and a FLIR C-5 thermal camera of the landfill to the east (Figures 1, 2, and 3). The thermal images indicate warm zones on the landfill slope directly above the lower road.

Figure 1: Thermal image of landfill from quarry haul road facing east. Note warm colors along lower landfill perimeter road starting from upper right corner and extending to the left.

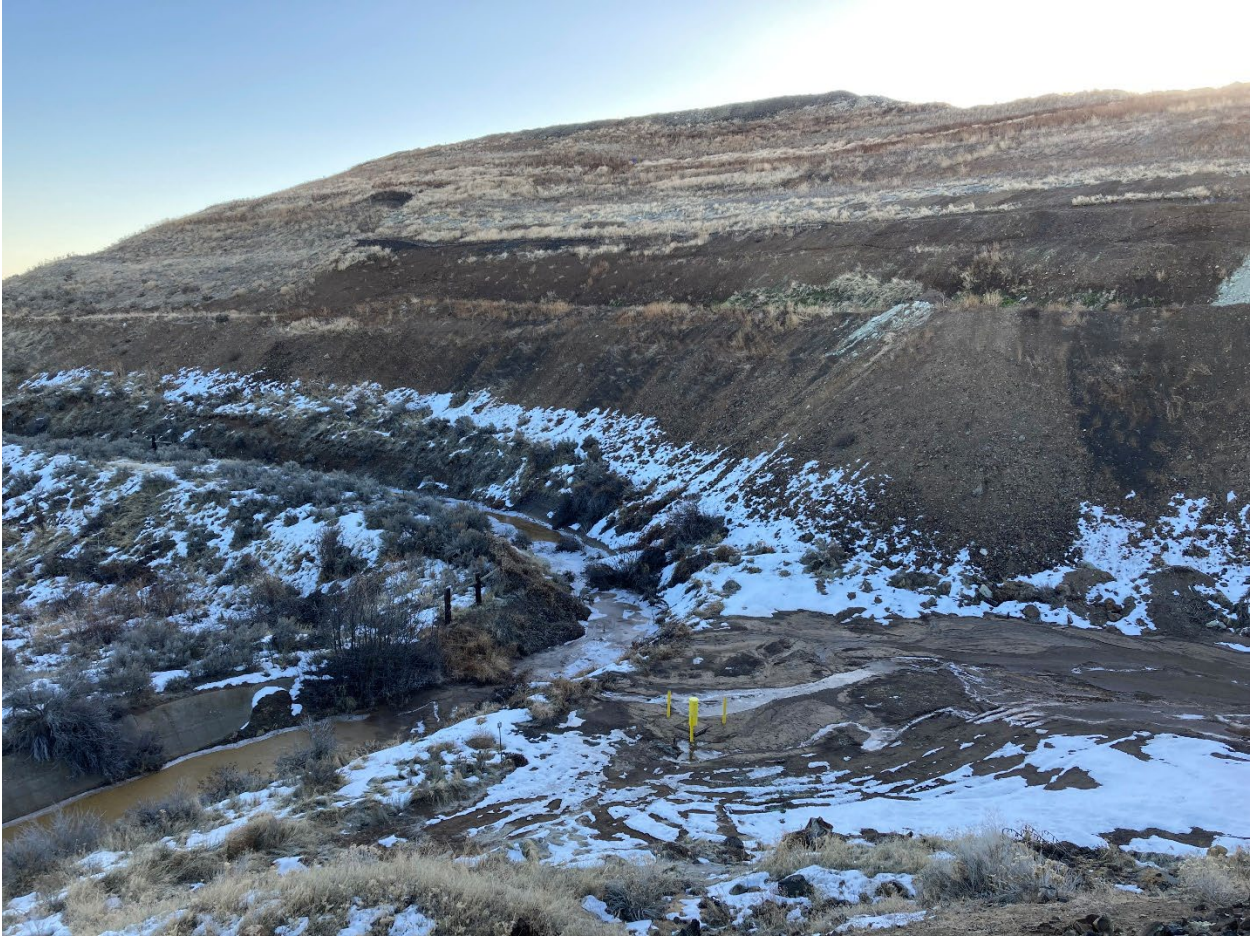
Figure 2: Photograph from same vantage point as Figure 1. Note green vegetation above perimeter landfill road.

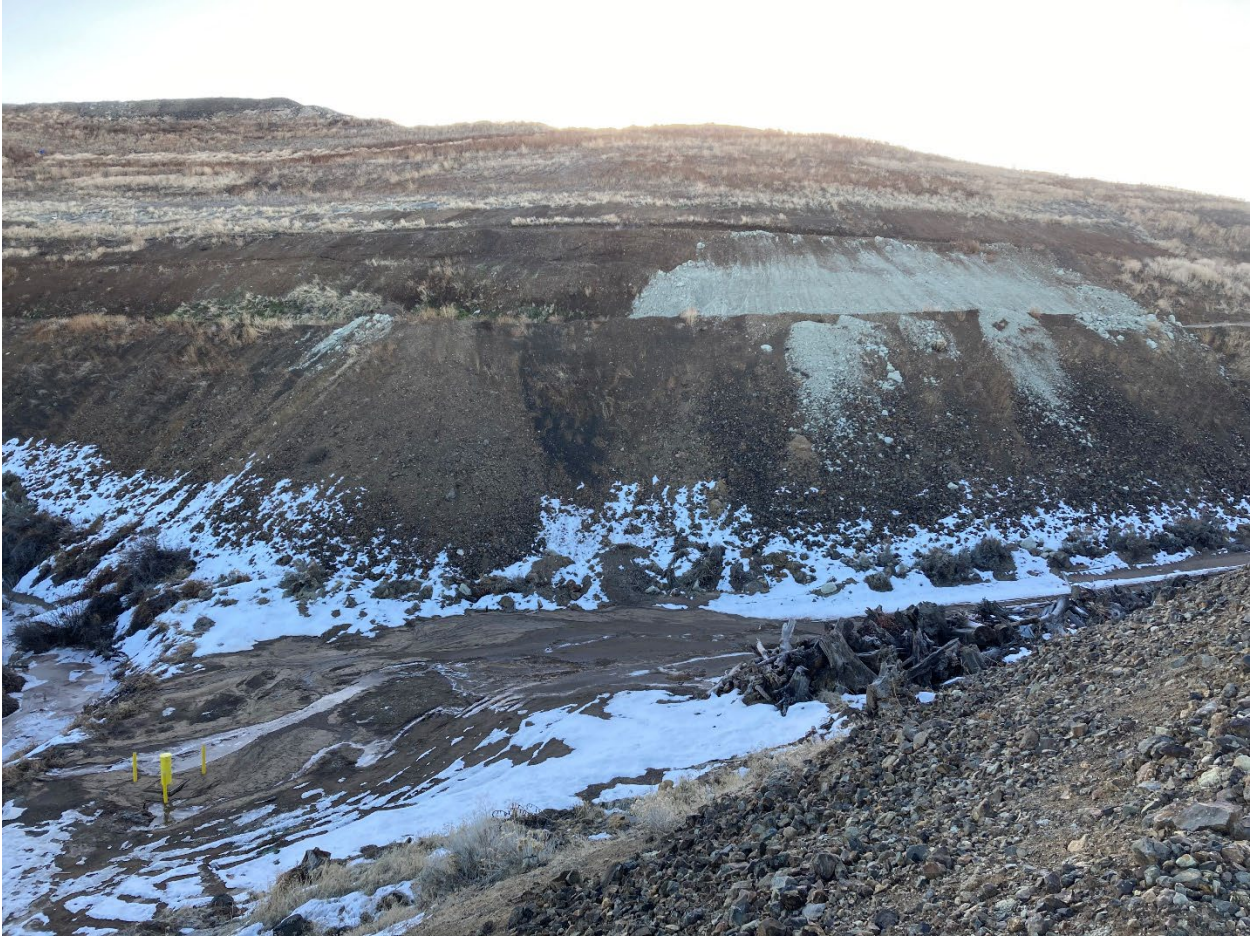
Figure 3: Photograph from same vantage point as Figures 1 and 2 facing southeast. Note light gray soil that has been placed over previously documented hot-spot above perimeter landfill road and green vegetation to the left.

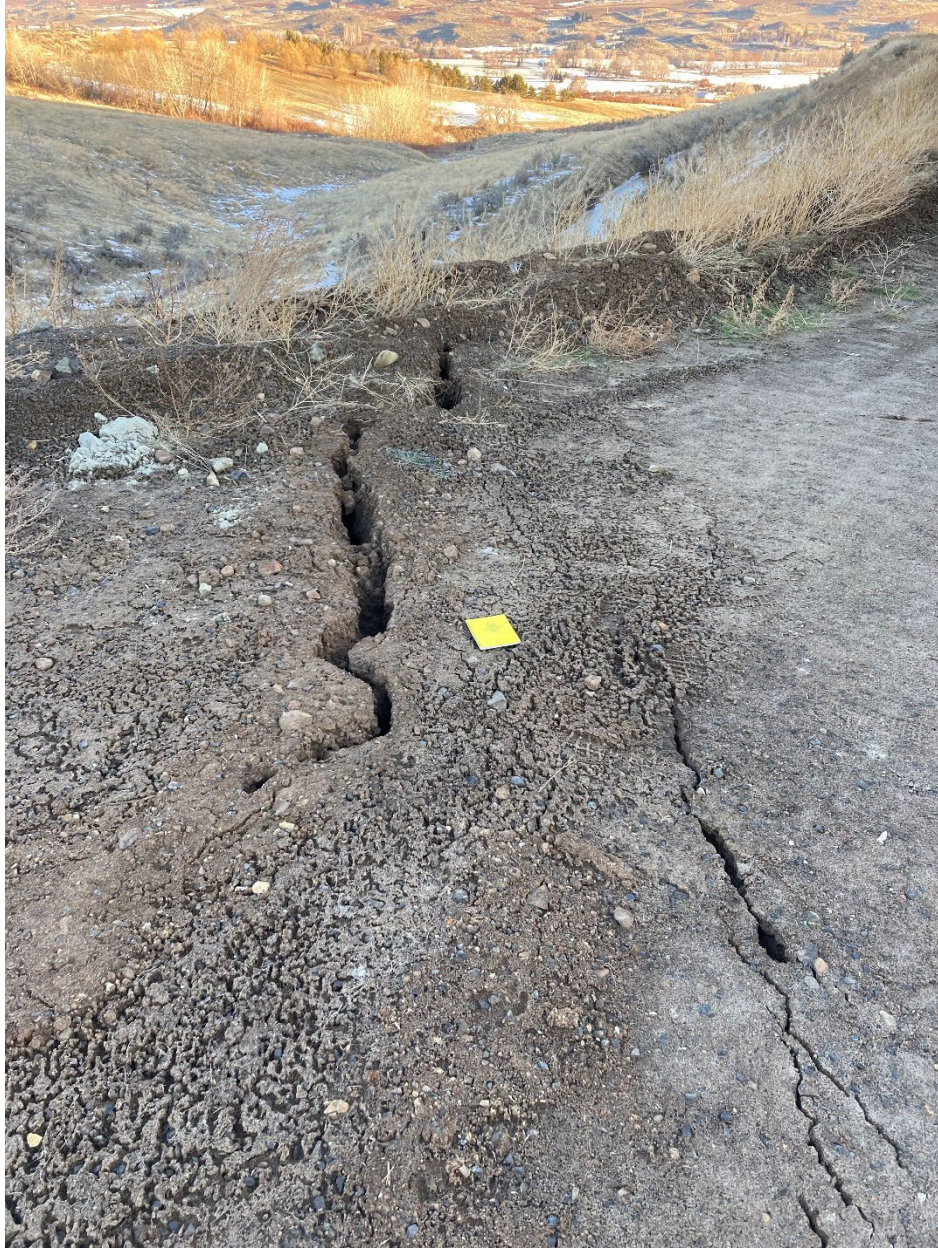
After walking the draw, I walked the lower road on the northwest flank of the landfill. The soil in this area was not frozen, in contrast to all the soil along the quarry haul road and in the draw. Numerous cracks were observed in and adjacent to the road (Figures 4 and 5). Cracks in the road have been observed in this area before, but they are now significantly larger than in the past. Areas of green vegetation and warm thermal signatures were observed adjacent to the road as well (Figures 5 and 6).

Figure 4: Cracks on perimeter landfill road.

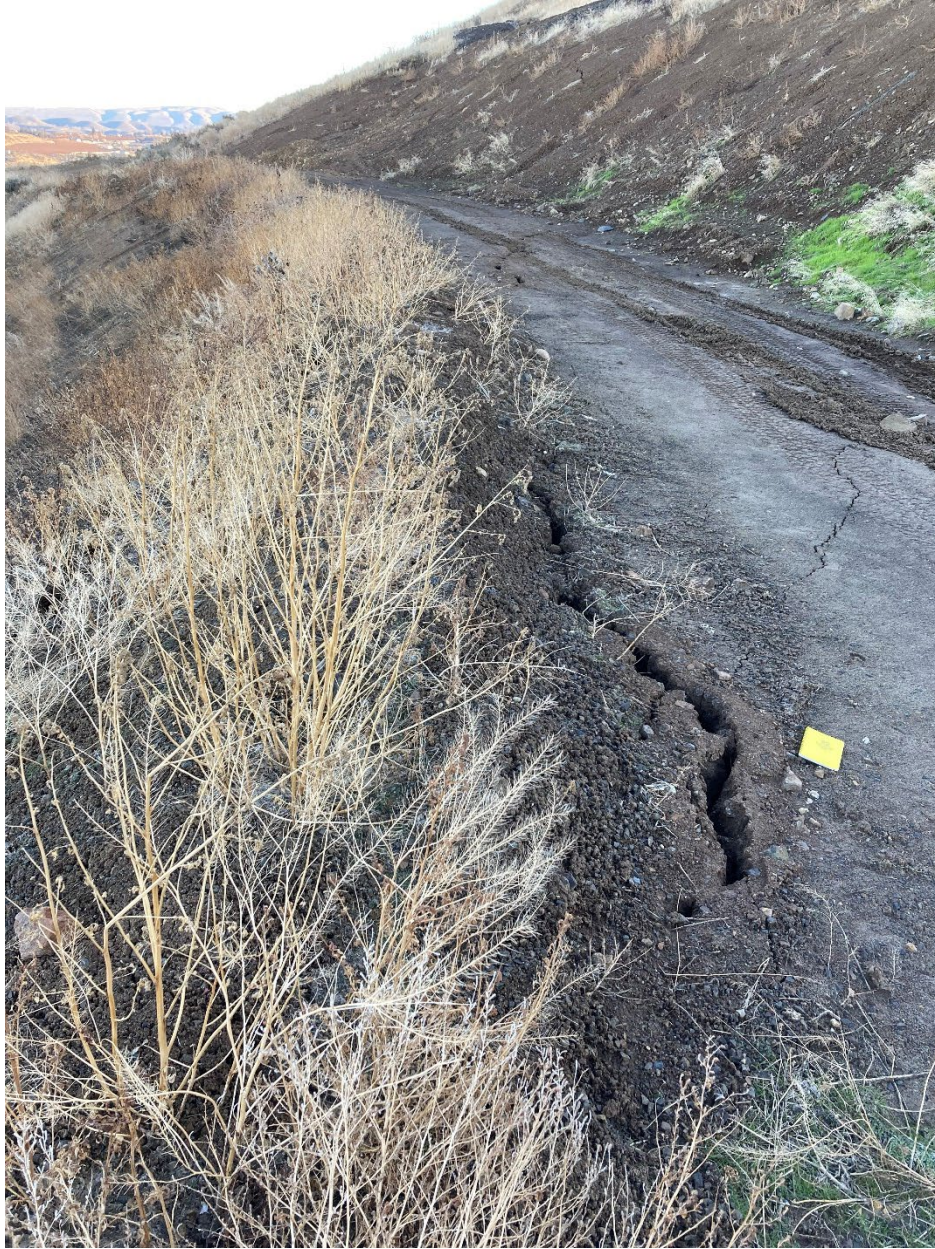
Figure 5: Cracks on perimeter landfill road. Note green vegetation on the opposite side of the road.

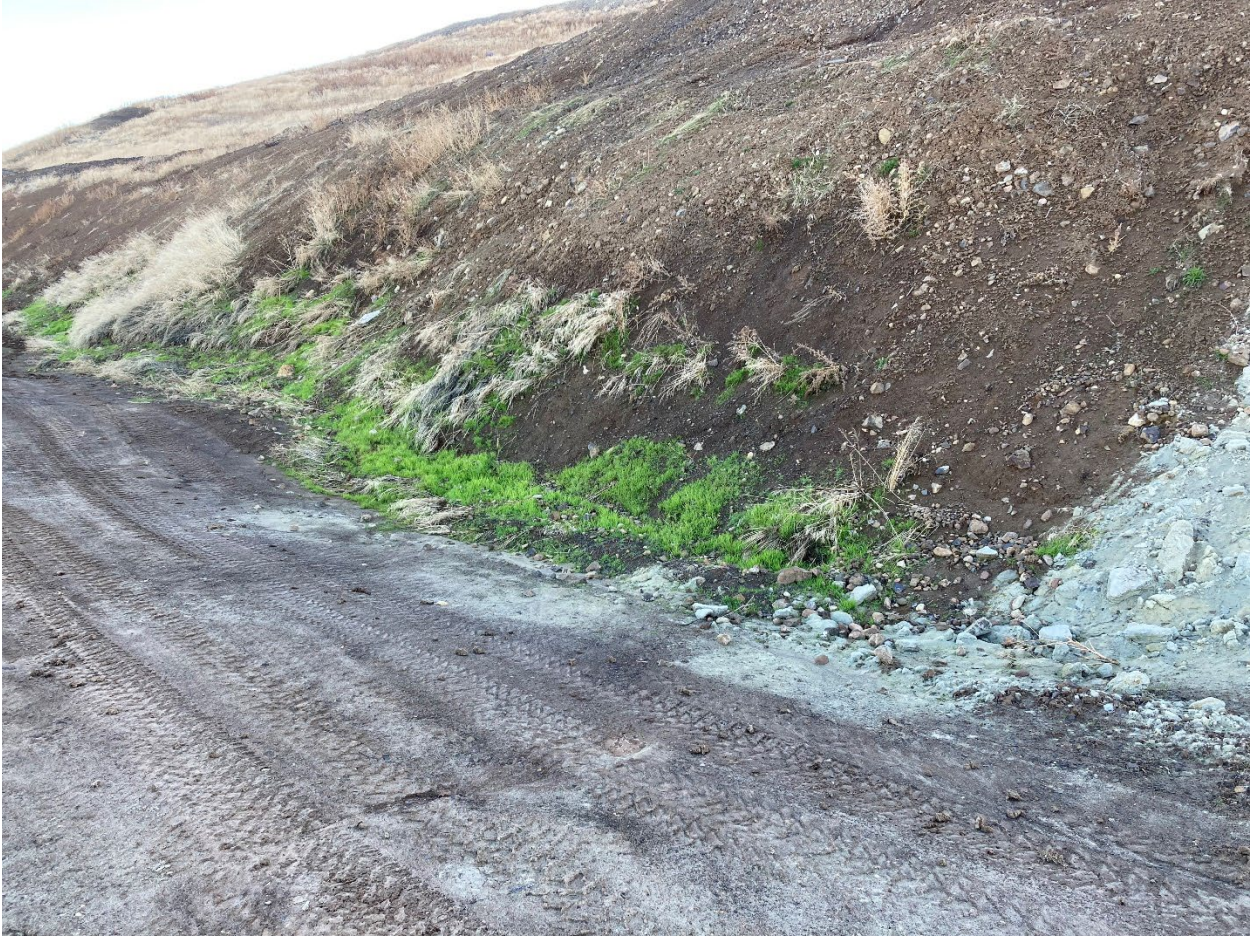
Figure 6: Close-up view of green vegetation along perimeter road.

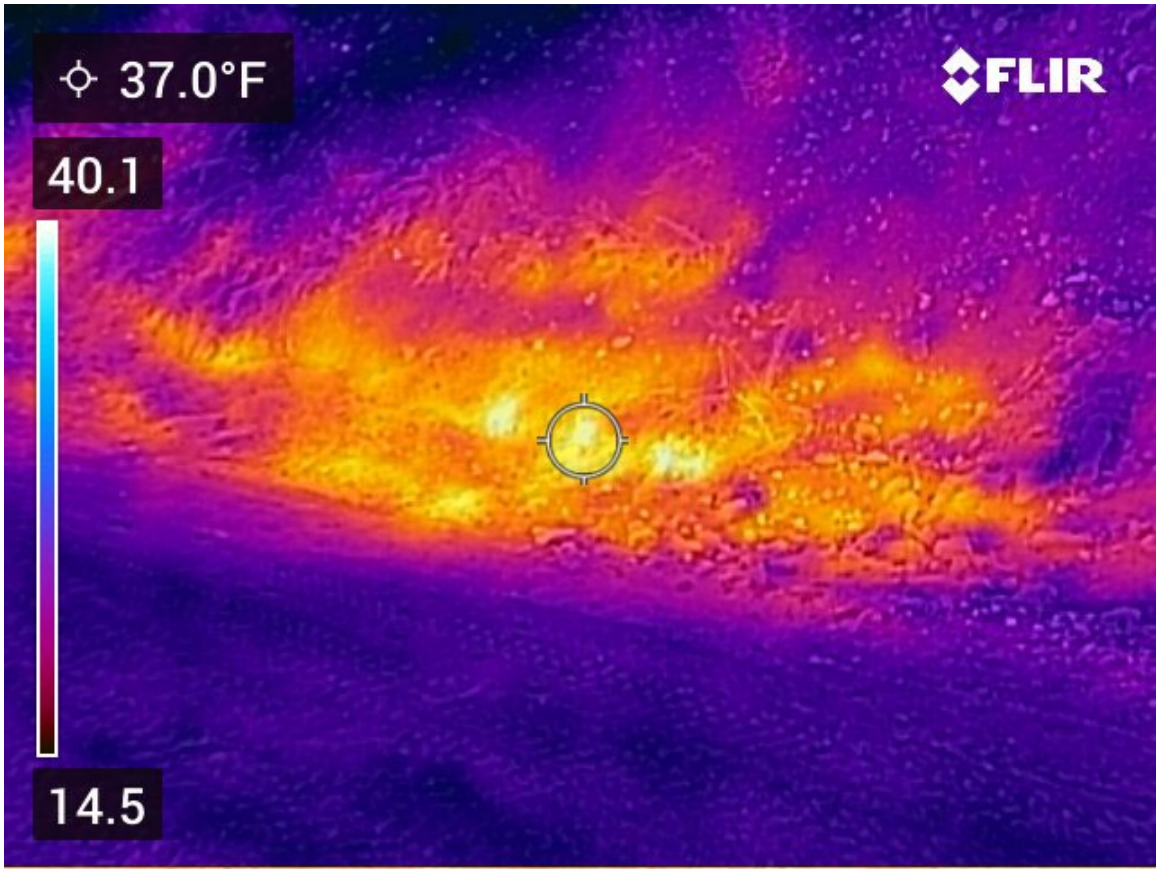
Temperature of the soil in the area of green vegetation was approximately 25F warmer than the road adjacent to it (Figure 7). Odors were noticeable in this area.

Figure 7: Thermal scan of green area from Figure 4.

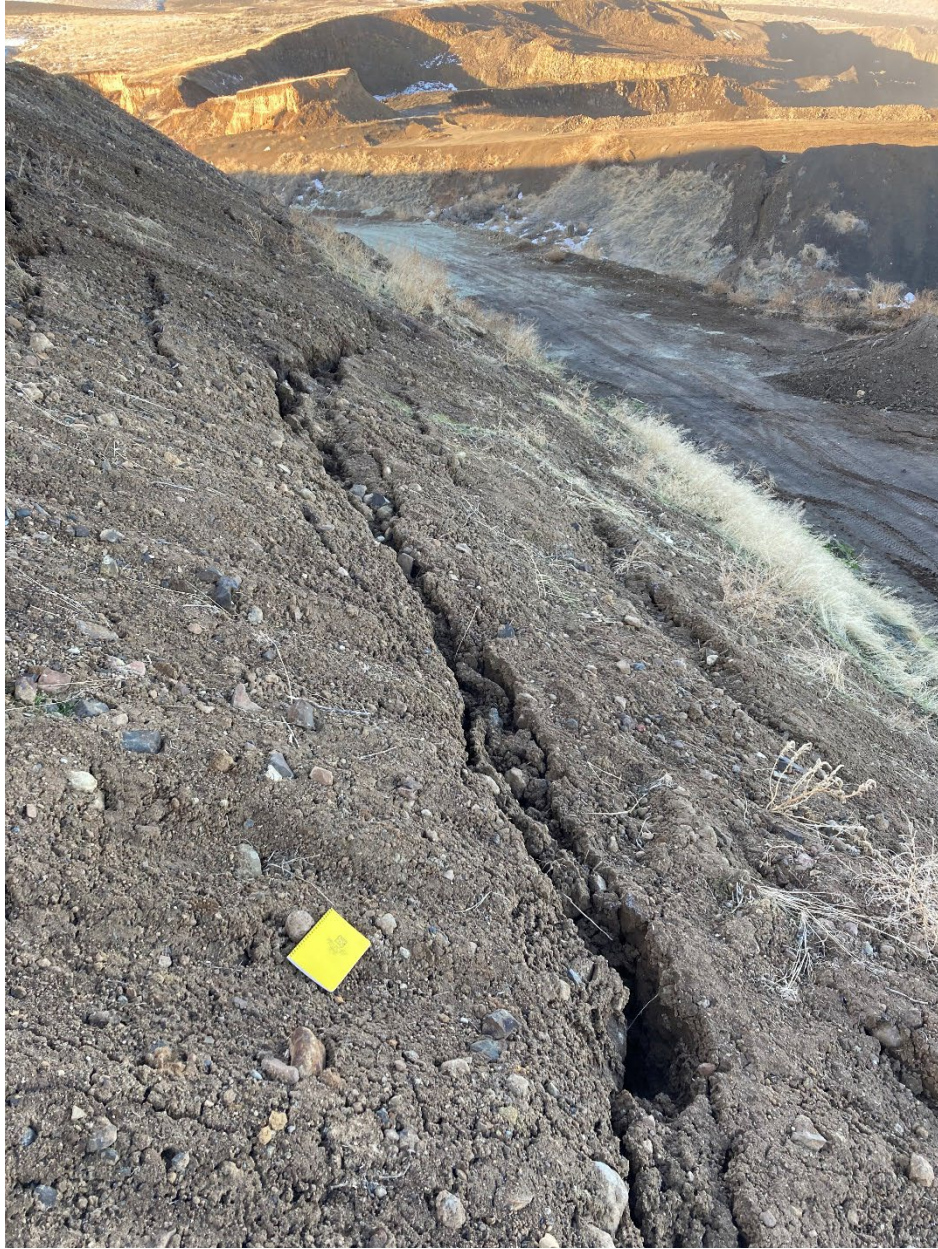
After following the cracks for a few hundred feet past the previously documented hot-spot, the cracks ended and I walked up the slope to the upper road. Numerous large cracks were observed in the flank of the landfill between the two roads running roughly parallel to the contours of the slope (Figure 8). Odors were strong in this area. Roughly directly upslope from the green vegetation noted earlier was a series of fine cracks with black residue around them producing smoke/vapor and very strong odor (Figures 9 and 10). Thermal images of these cracks indicate temperature of roughly 90F, approximately 73F warmer than the surrounding soil (Figure 11).

Figure 8: Cracks in slope above perimeter access road. Green vegetation directly below.

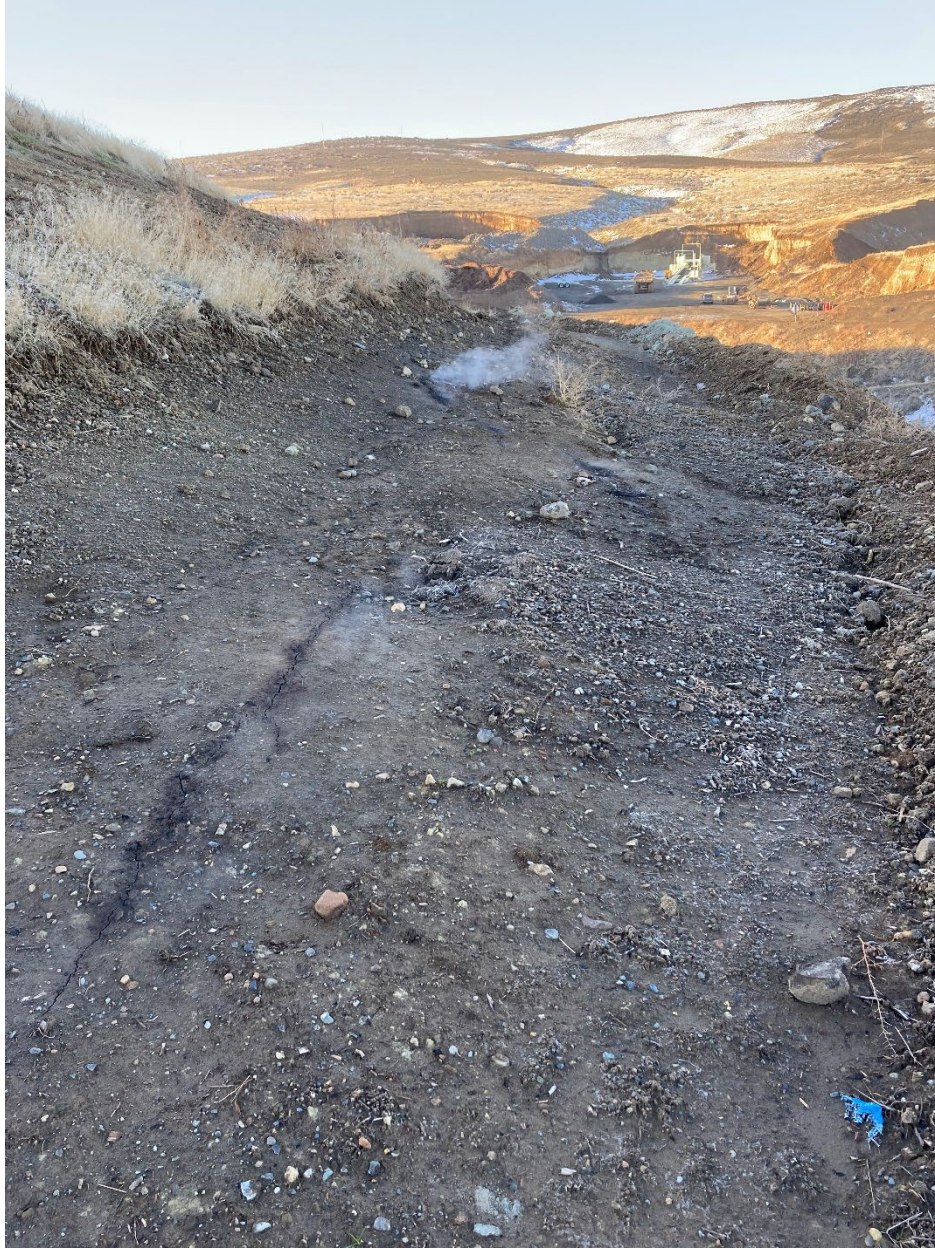
Figure 9: Facing south. Fine cracks in upper road above repaired slope with black residue around cracks and smoke/vapor emanating from cracks.

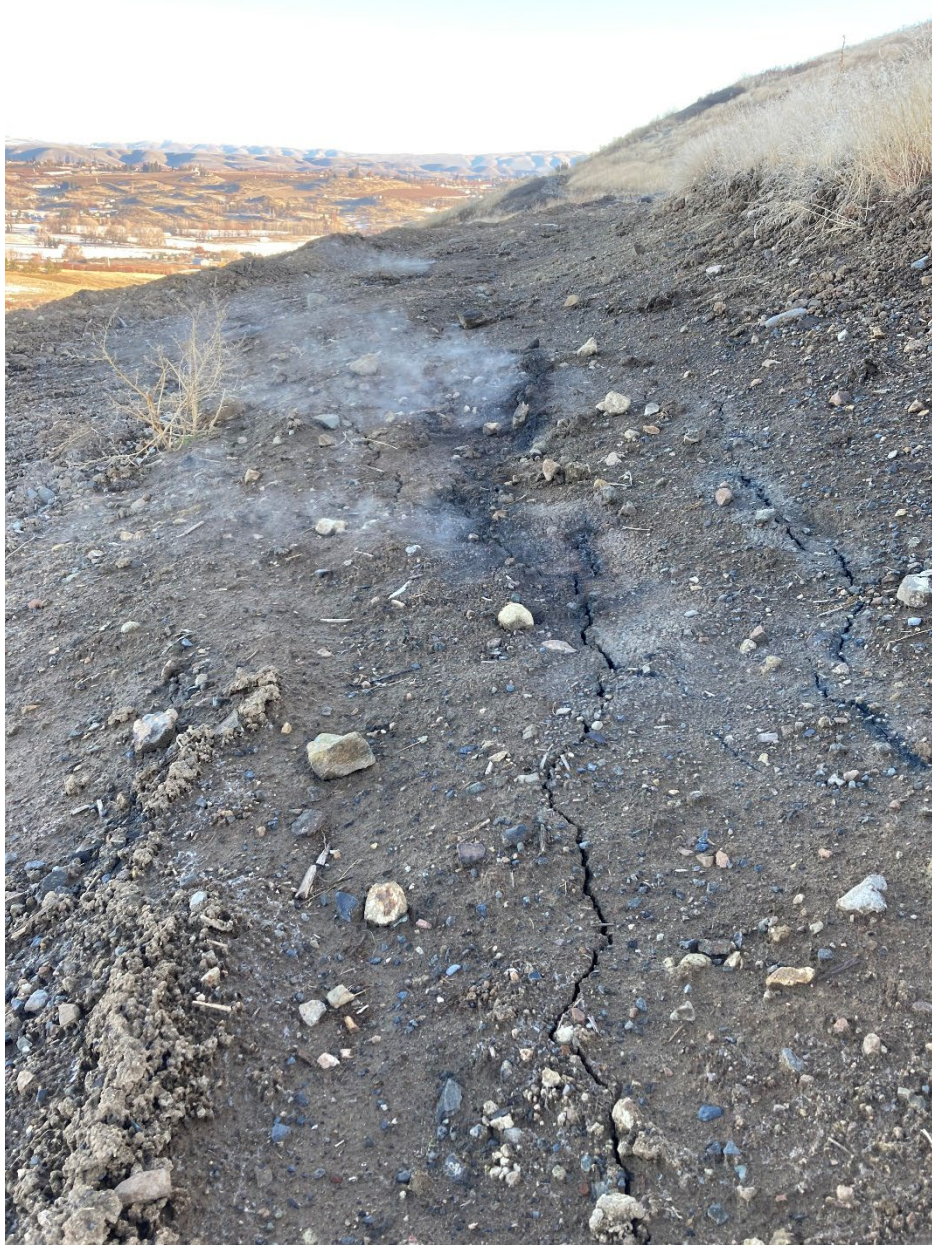
Figure 10: Facing north. Fine cracks in upper road above repaired slope with black residue around cracks and smoke/vapor emanating from cracks.

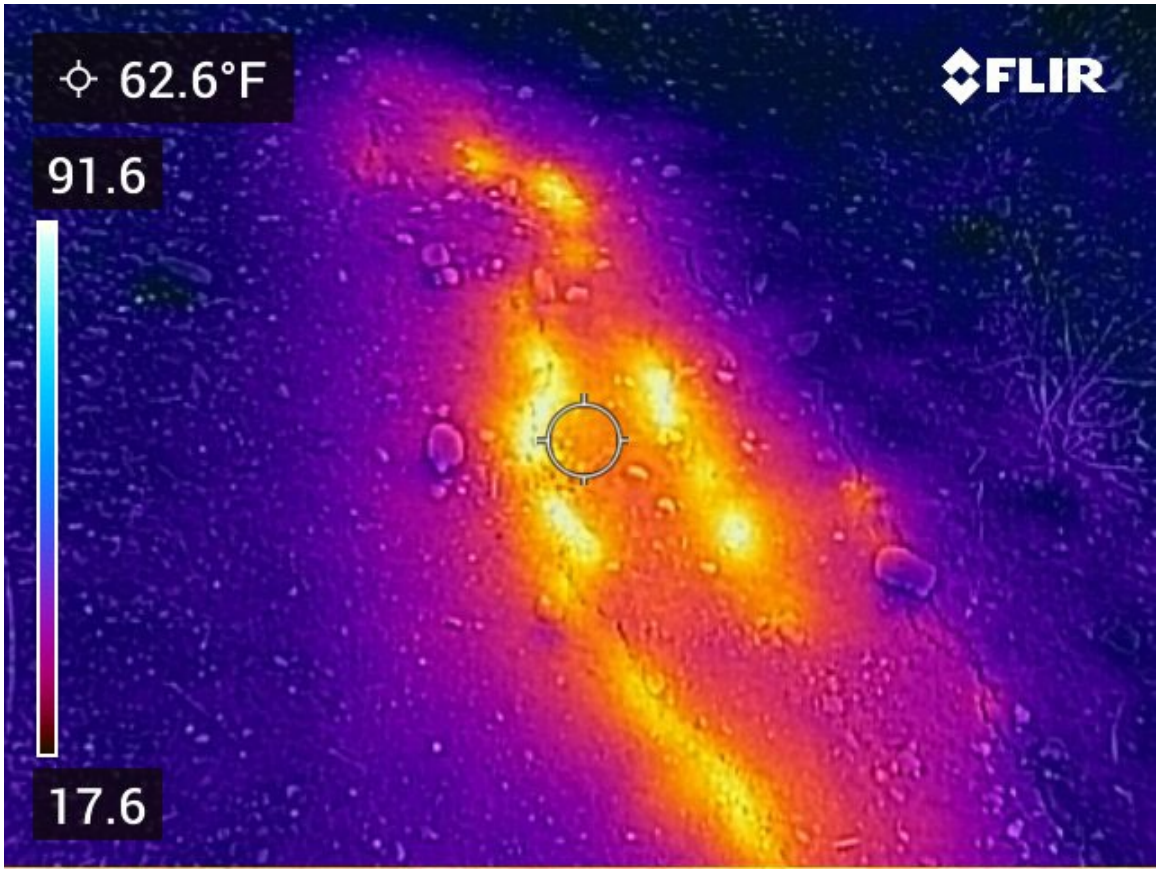
We have previously suspected a subsurface fire in this area, but indications at the time were somewhat ambiguous. Observations from January 19, 2023, collectively indicate ongoing combustion beneath the surface.

Figure 11: Thermal scan of cracks on upper road.
